Use of geotubes in Colombia, South America

This paper describes two case histories of geotube projects constructed in Colombia, South America. The first case history involves one of the first locations in South America where geotubes were used for construction of confined disposal area islands used for containment and dewatering of fine-grained maintenance dredged materials. This project is located on the San Antonio Inlet, Buenaventura Colombia. This dredged material containment area was the first of two circular shaped islands planned in this riverine and tidal environment. This new and innovative construction methodology involved hydraulically filling geotubes with a sandy fill material. Geotubes are simply an assemblage of geotextile fabric panels sewn to form long tubes for containment of dredged material. The geotubes were positioned end to end to provide a perimeter dike for dredged material containment in tidal variations of 4 m twice a day. After the first island was completed, it served as a dredged material containment facility until it was filled. After it has stabilized, it will be planted in Mangrove trees and other native vegetation and will be used exclusively for

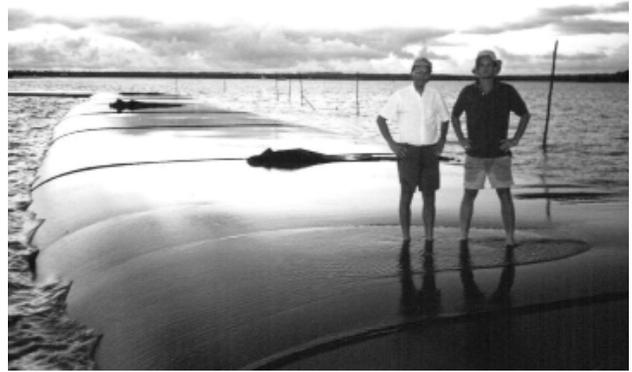
Figure 1. View of geotube being filled.

The construction plan for the first disposal area was to hydraulically fill eleven 100-meter long geotubes with sandy dredged material from the navigation channel to form the perimeter dike for the circular shaped disposal areas. The geotubes positioned along the proposed alignment were temporarily anchored during filling with 4-meter long poles that were attached to nylon straps pre-sewn along each edge of the geotubes. The contractor made every attempt to locate the more sandy materials for filling the geotubes. Initial filling attempts resulted in too many light weight fine materials in the far end of the 100-meter long geotube and tidal fluctuations cause the first geotube to get slightly off the proposed alignment. To minimize this effect the geotubes were filled in increments of 25 meters with sand with the un-filled portion resting on a small barge until the next 25 meters of geotube was needed. During the filling of the geotubes, a certain portion of the fine-grained dredged material was allowed to flow into the disposal area to maximize sand fill in the geotube (Figure 1). The contractor located the dredge within the disposal area during filling of the geotubes to maximize storage capacity.

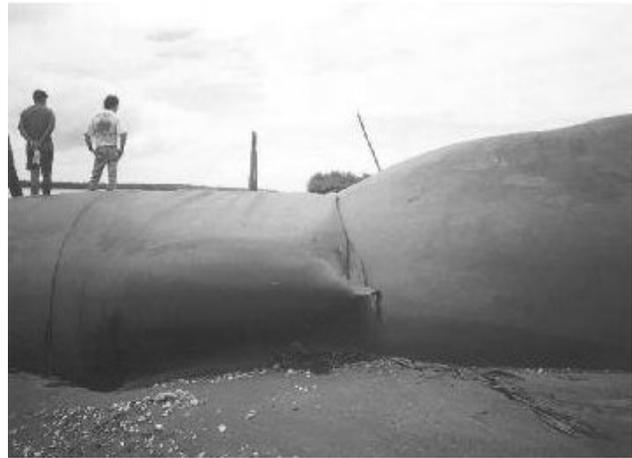
The contractor finally worked out a scheme for joining the geotubes to form a watertight joint (Figure 2). This was accomplished by pulling enough slack up onto the existing geotube prior to filling from the opposite end. As the filling operation approached the existing geotube it would form fit around the filled geotube.

Figure 2. Example of watertight joint with two joining geotubes.

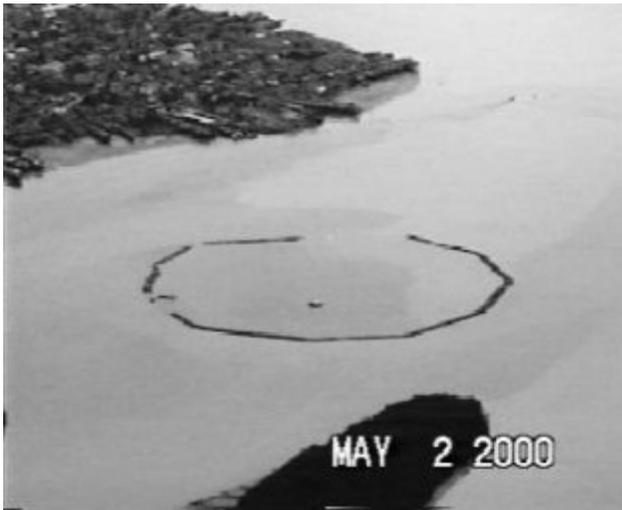
Placement of the last geotube to close the island perimeter was very difficult. Four-meter high tides, twice daily, caused water to pond in the disposal area. Deep scour holes developed at the edge of the geotubes along the opening. The opening was close by filling a 25-meter long Geotube positioned across the opening (Figure 3).

Figure 3. Aerial view of geotube island after construction.

The first disposal area was about 1100 meters in circumference and 350 meters in diameter. It was estimated to contain about 300,000 cubic meters of maintenance material. The second disposal area was designed to be 1600 meters in circumference and 500 meters in diameter. This disposal area should contain an estimated 600,000 cubic meters of maintenance material. At this writing, the second disposal area has not been constructed.

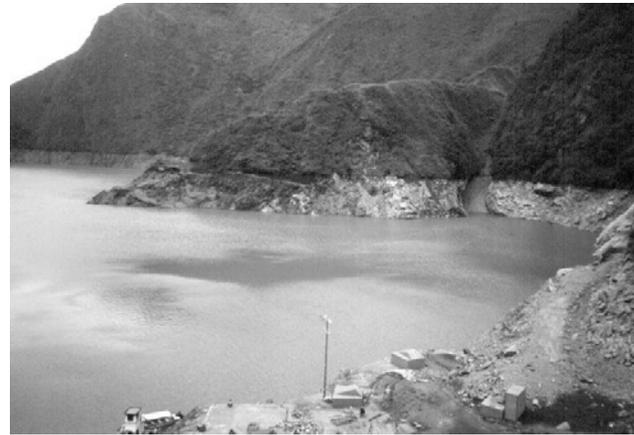
Figure 4. Rock and surficial sediment slides were potential danger to turbines.

construction tunnel that was inadvertently left open after construction and filling of the reservoir. The bypass tunnel was located in the very bottom of the reservoir and served to bypass surface water during construction of the earth and rock filled structure. Since construction in 1980, reservoir sediments have accumulated to a depth that exceeds the height of the tunnel. An erosion channel had formed at the mouth of the tunnel opening indicating that fine-grained lake sediments had been entering the tunnel for quite some time. In addition to the normal accumulation of lake sediments, recent rockslides in 1998 occurred on the east abutment above and near the tunnel. Surficial sliding of sediments continues to occur along these scarped faces and the possibility of large cobble size particles entering the tunnel and causing complete destruction of the turbines was eminent (Figure 4). The tunnel had to be closed immediately without causing an increase of sediments to enter the tunnel during closure.

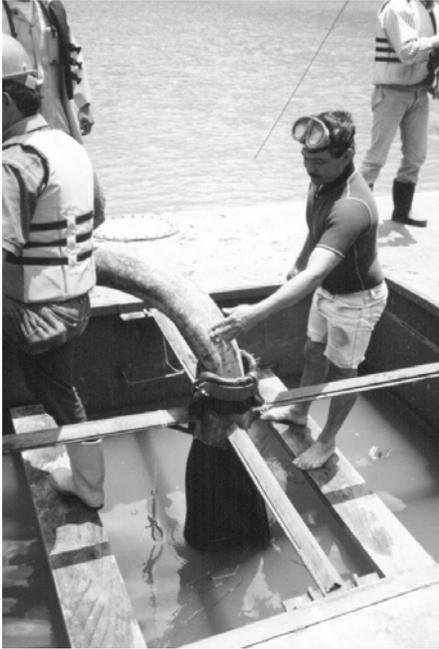
Geotube placement was accomplished with the use of a specially designed steel pontoon barge that was outfitted with four sets of electric winches and side boom cranes that were attached to a steel cradle positioned under the barge. The barge was 20 m long and 10 m wide and the two pontoon sections were welded together to form an opening at the mid point for filling the geotubes. The cradle was submerged under and positioned in the center and perpendicular to the longitudinal axis of the barge. The cradle contained the geotube during filling with concrete and during placement in front of the tunnel (Figure 5).

Figure 5. Filling of geotube in cradle.

The depth of water under the barge at the tunnel location was 100 m. The cradle was lowered to a depth of 90 m and tilted to allow the geotube to roll out of the cradle falling the last 10 m in front of the tunnel opening. Horizontal positioning of the placement location was accomplished through the use of a Global Positioning System (GPS), and triangulation was accomplished using laser survey equipment located on shore and on the barge. Twenty-five geotubes were successfully placed in front of the tunnel opening, closing the opening and preventing the loss of sediment. The project began in mid April 1999 and was completed in mid May 1999.

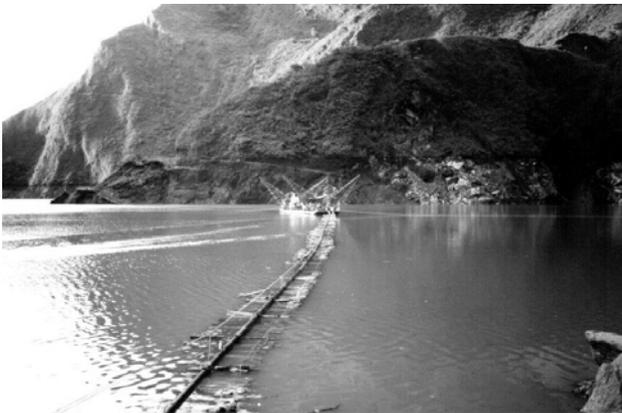
Five-inch slump concrete was pumped 200 m from the shoreline to the placement barge with a positive displacement concrete pump. The high-pressure steel pipe used to transport the concrete from the shoreline to barge and geotube was supported from the shoreline on a 2 m wide raft of logs and bamboo that were tied together with rope (Figure 6).

Figure 6. Raft of logs and bamboo supporting steel pipe transporting concrete.
